BEAVERLODGE RIVER WEIR MONITORING PROGRAM - 2019 SUMMARY REPORT

BEAVERLODGE RIVER
SE ½ 34-071-10 W6M

Prepared for:
MIGHTY PEACE WATERSHED ALLIANCE

Prepared by:
MATRIX SOLUTIONS INC.

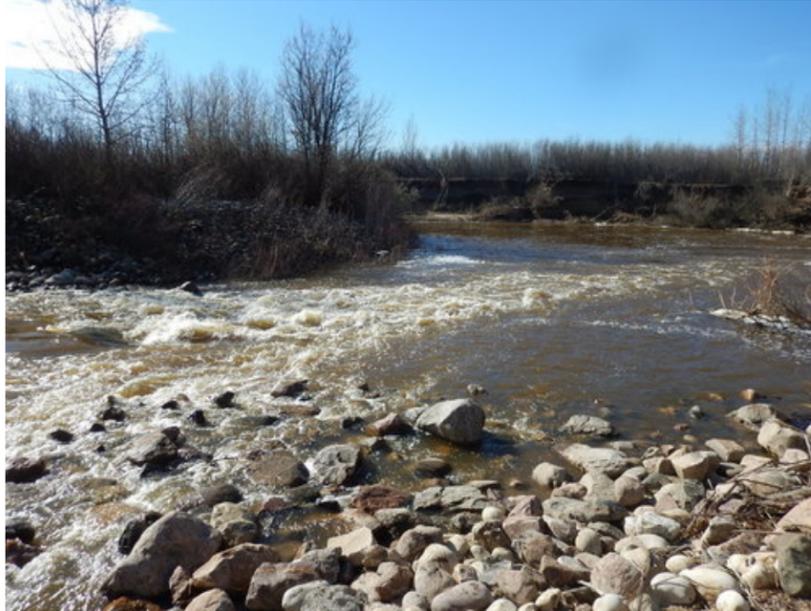
1. BL1, viewing downstream (May 2019)

The MPWA conducted willow planting in the summer of 2019. Plantings occurred along the south bank from Riffle 2 for a distance of 30 m upstream; planting could not be conducted further upstream as the high, unstable bank presented overhead safety concerns (Appendix A, Photographs 1, 16, 19).
