Town of Grande Cache

Source Water Protection Plan: Victor Lake and Grande Cache Lake

March 2015

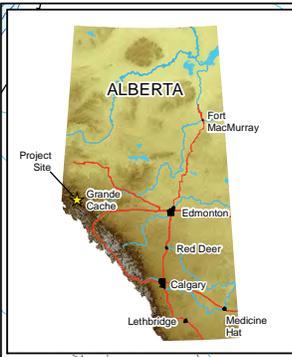
PROJECT:		SOURCE WATER PROTECTION PLAN: VICTOR LAKE	
PROJECT NO.:	2014-3013.000.120	FIGURE 1-1: VICTOR LAKE & GRANDE CACHE LAKE WATERSHED & INTAKE LOCATIONS	
FILE:	figure1.mxd		
DATE:	Dec. 2014

The Town's source of domestic water is Victor Lake, which is located about 1.9 km southeast of the Town centre. The water is pumped in through an intake off the north shore of the lake (Figure 1-1), and pumped up hill for treatment and storage in a reservoir. Victor Lake is connected by a channel to Grande Cache Lake that was reportedly constructed in 1975-1976 to manage water levels in Victor Lake, although the reason for the works (termed a "diversion ditch") is not stated in the provincial authorization (Licence of Occupation 5793). The Town's raw water diversion license includes both Victor Lake and Grande Cache Lake. It is understood that the flow in the diversion ditch is predominantly from Victor Lake to Grande Cache Lake, but the lake levels are very similar and flow in the opposite direction reportedly happens on occasion. As a result, it is likely that the diversion ditch enables the raw water diversion to be withdrawn from the combined volume of both lakes.

The main drinking water intake for the Towns drinking water system is located approximately 10 m out from the north shore of Victor Lake (Figure 1-1 and Map 1), at a depth of about 3 m below the average annual ice level. The pump house is located on the lake shore, less than 10 m back from the high water mark. This is the second intake that has been built on the lake. The original intake is located about 260 m east and now serves as the back-up intake. Its pump house is also situated close to the shoreline and the intake is at a depth of about 2 m below ice level.

The Town of Grande Cache (Town) is located in the Rocky Mountains of western Alberta, approximately 160 km northwest of Jasper National Park on Highway 40 (Figure 1-1). The population of the Town, according to the last (2011) census, is 4,319 persons. In addition to the Town's population, the Grande Cache Institution includes a 243 inmate capacity. Municipal and Federal Census reports for the Town for years between 1975 and 2011 suggest an average historical annual growth rate of 0.6%. The Town has recently approved a 1.0% growth rate for their current infrastructure projects, and a 25 year projected population of 5,950 (2039). The most recent Municipal Development Plan provides for an increase of up to 9,000 people for the ultimate build-out (Town of Grande Cache 2012).

The area addressed by the SWPP is the watersheds draining to Victor and Grande Cache Lakes (Figure 1-1 and Map 1 (attached in Appendix B; henceforth "the plan area"). As noted above, the predominant flow direction between the lakes is from Victor Lake to Grande Cache Lake. Therefore risks in the Victor Lake watershed are considered a higher priority for action (refer to Section 1.4).

As described in Section 1.1, construction of the diversion ditch between Victor Lake and Grande Cache Lake in 1975-1976 changed the nature of the connection between the two lakes. In addition, a weir at the outflow of Grande Cache Lake influences the water levels in both lakes. As a result, the watershed contributing to the Victor Lake source is the catchment areas of both Victor Lake and Grande Cache Lake (Figure 1-1 and Map 1). This area is referred to as the plan area in this report.

There is a tributary to Carconte Creek that runs through the closed mine and drains into Grande Cache Lake from the southeast (Figure 1-1); therefore potential exists for the transfer of contaminants from the garbage that is being disposed of at the site. Contaminants from that mine site could potentially travel into Grande Cache Lake via groundwater infiltration.
