Monitoring and Management in the Peace-Athabasca Delta

Outline

- What makes the Peace-Athabasca Delta unique
- Threats to water quality and quantity
- Monitoring efforts: PADEMP, CBM, ECCC, PARKS, TEK, external research, etc.
- Management strategies: current and future

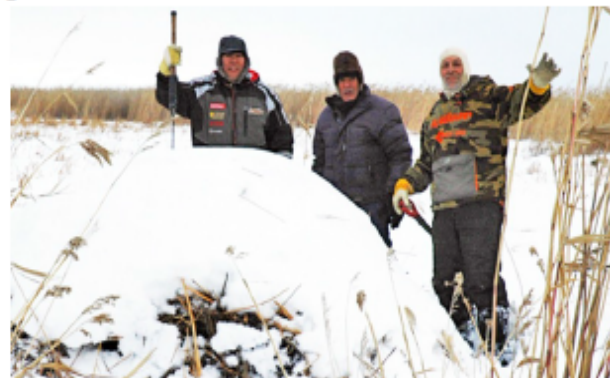
David Campbell, left, Archie Antoine and Ross Campbell pose with a large rat house in the delta.

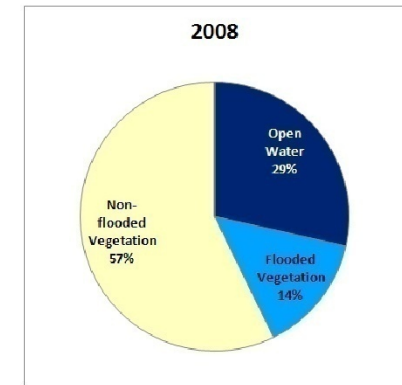
2008

Open Water	29%
Flooded Vegetation	14%
Non-flooded Vegetation	57%

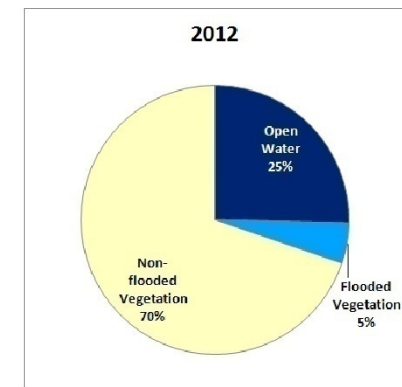
2012

Open Water	25%
Flooded Vegetation	5%
Non-flooded Vegetation	70%
