BEAVERLODGE RIVER WEIR MONITORING PROGRAM - 2019 SUMMARY REPORT

BEAVERLODGE RIVER
SE ½ 34-071-10 W6M

Prepared for:
MIGHTY PEACE WATERSHED ALLIANCE

Prepared by:
MATRIX SOLUTIONS INC.

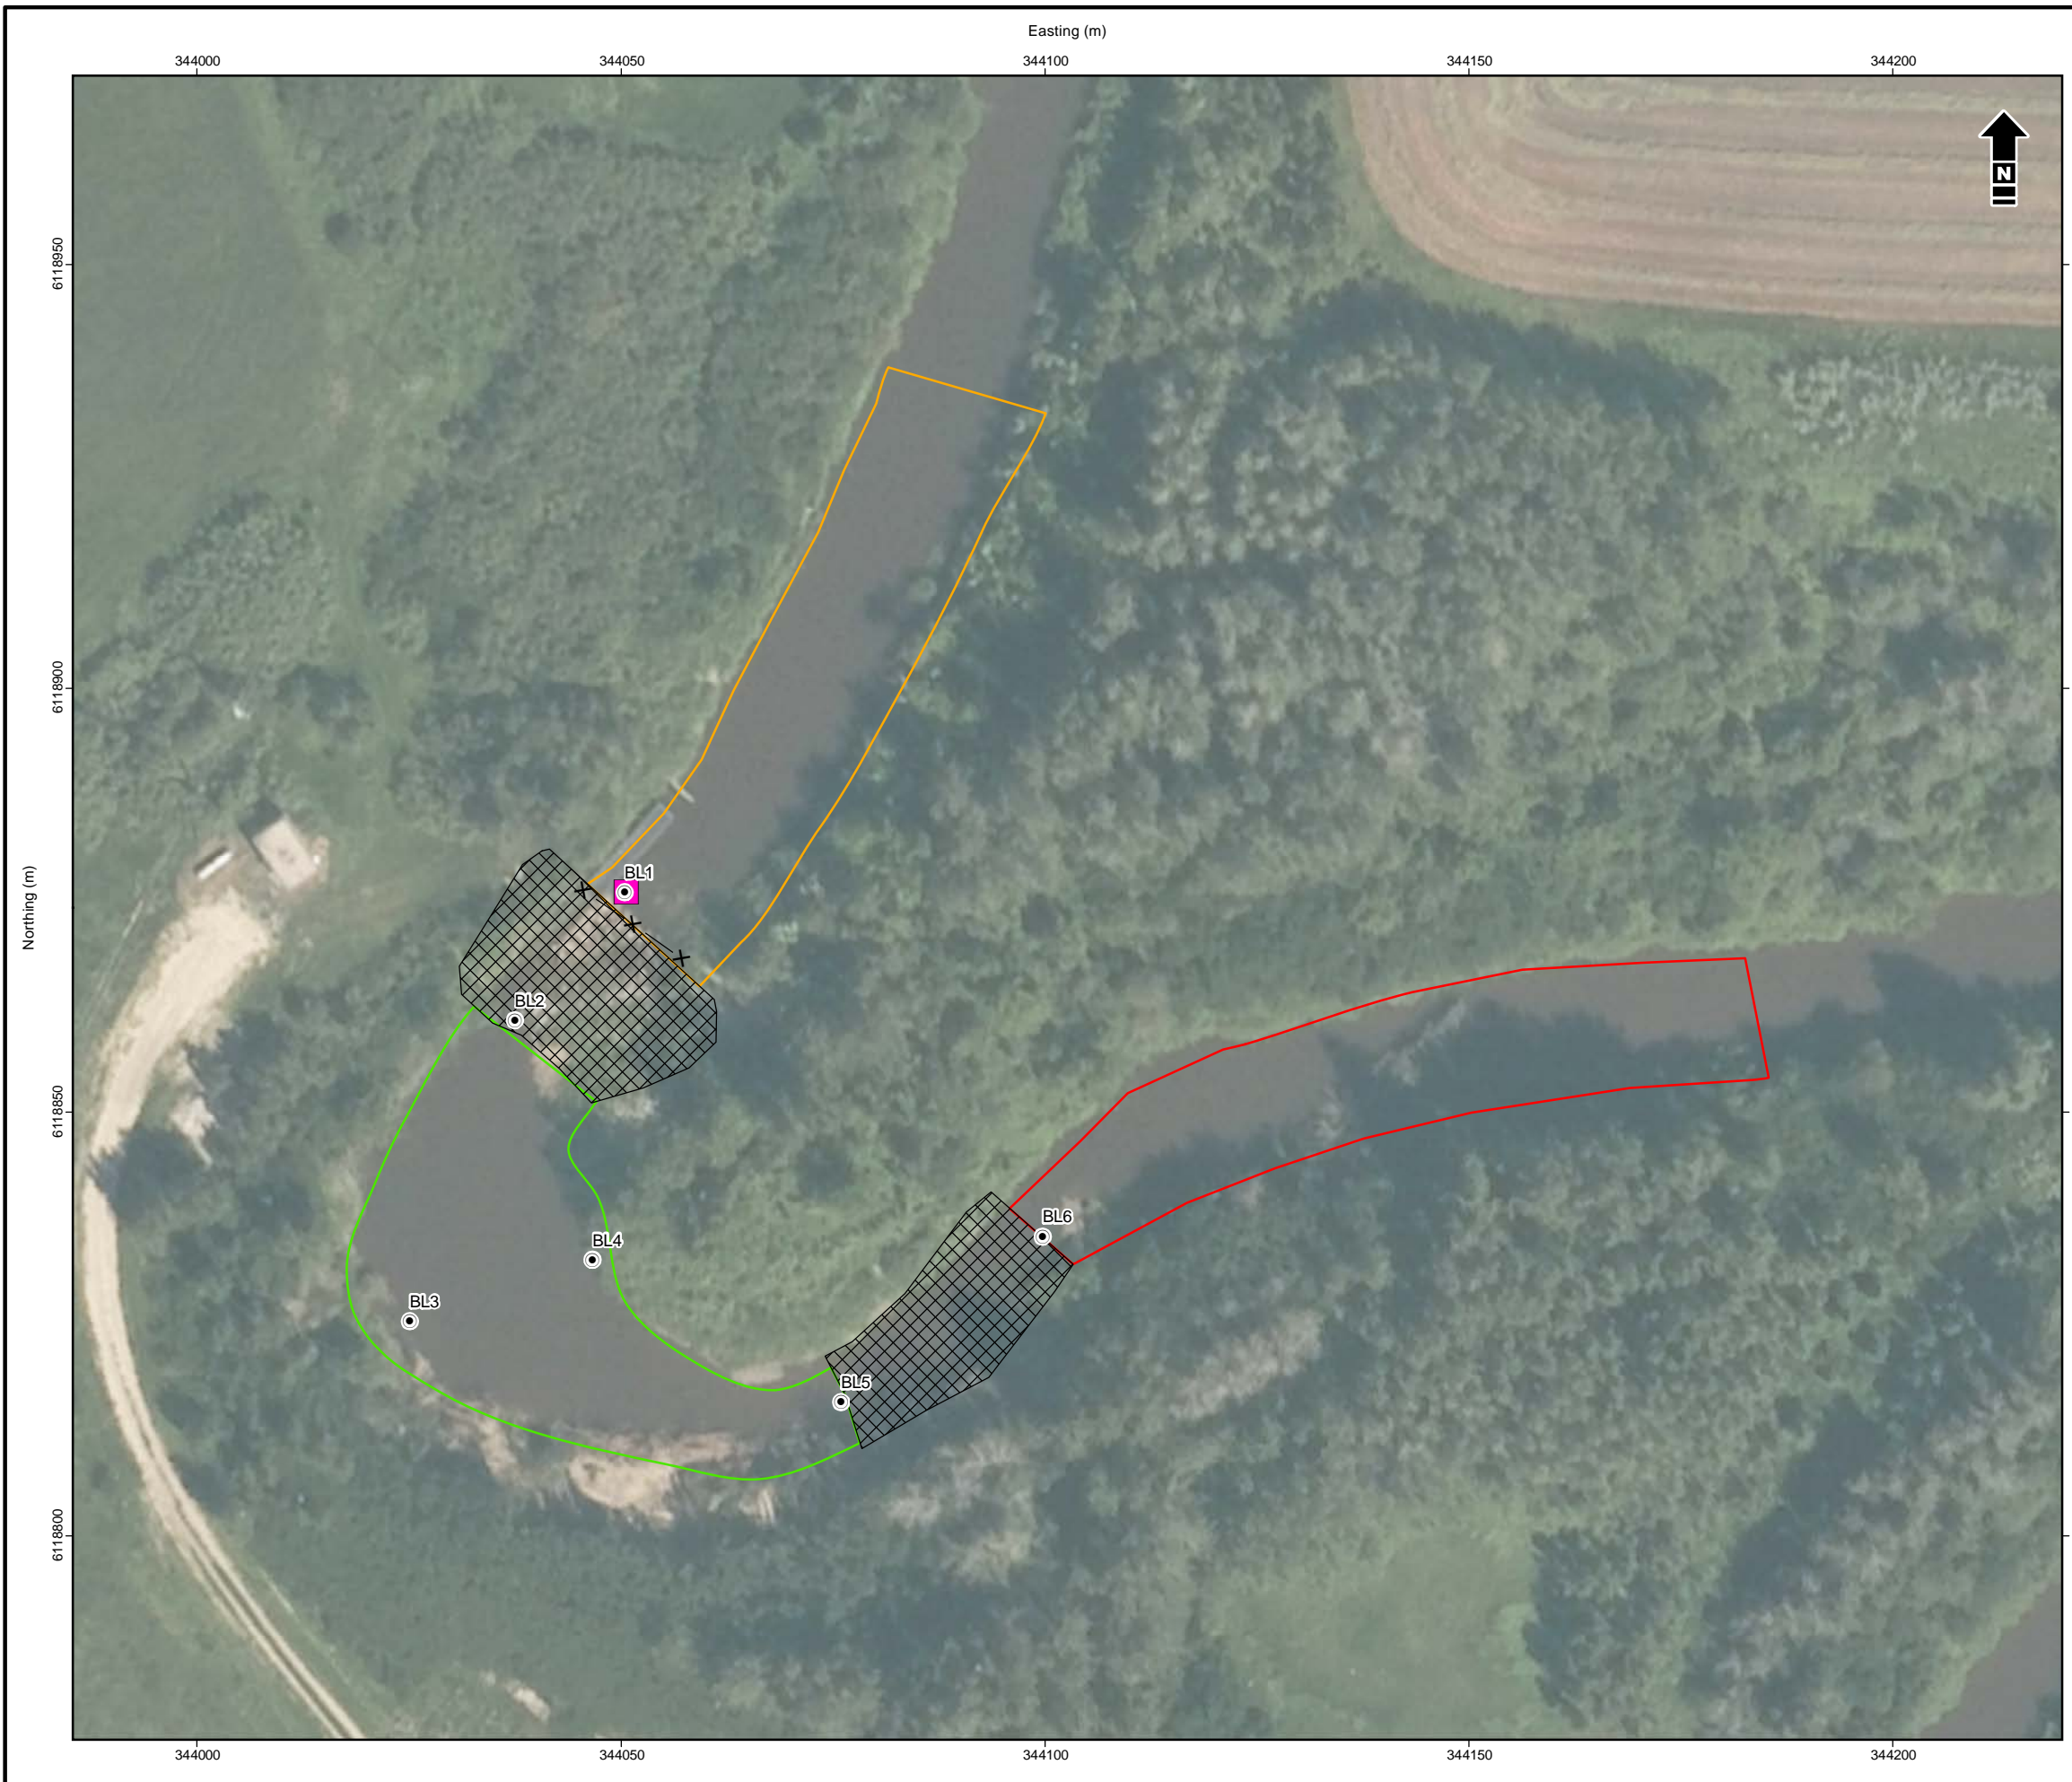
Site Plan

Site inspections, hydrology, and fish use monitoring were focussed on a 400 m reach of the Beaverlodge River: 100 m upstream of Riffle 1, within the large scour pool downstream of the Riffle 1, and 100 m downstream of Riffle 2 (Table 2-1; Figure 2-1):

- Six monitoring locations were established for annual site inspections, photographic documentation and water quality monitoring; site included four locations upstream and downstream of Riffle 1 and Riffle 2, and two locations within the scour pool between Riffle 1 and Riffle 2.

- Three fish sampling reaches were established; upstream of Riffle 1 (Reach 1), between Riffle 1 and Riffle 2 (Reach 2), and downstream of Riffle 2 (Reach 3).
- eDNA sampling was conducted over a larger extent over the Beaverlodge River (see Section 2.1.4); eDNA sampling occurred at six locations, including two locations upstream of the weir, immediately around the weir and riffle structures, and downstream sites between the weir and the confluence of the Red Willow River; the larger monitoring extent was to account for potentially low densities of Arctic Grayling in the river, and therefore low detectability of eDNA; grayling may be present in specific reaches of the Beaverlodge River.
- A pressure transducer was installed and stream discharge measurements taken immediately upstream of Riffle 1.

Habitat structure inspections were completed during each site visit to determine if conditions deviated from the engineered design or have changed since the construction completion (based on as-built drawings) in a manner that degrades fish habitat and/or prevents fish using the passage structure. Sites included BL1 to BL6 (Table 2-1; Figure 2-1).

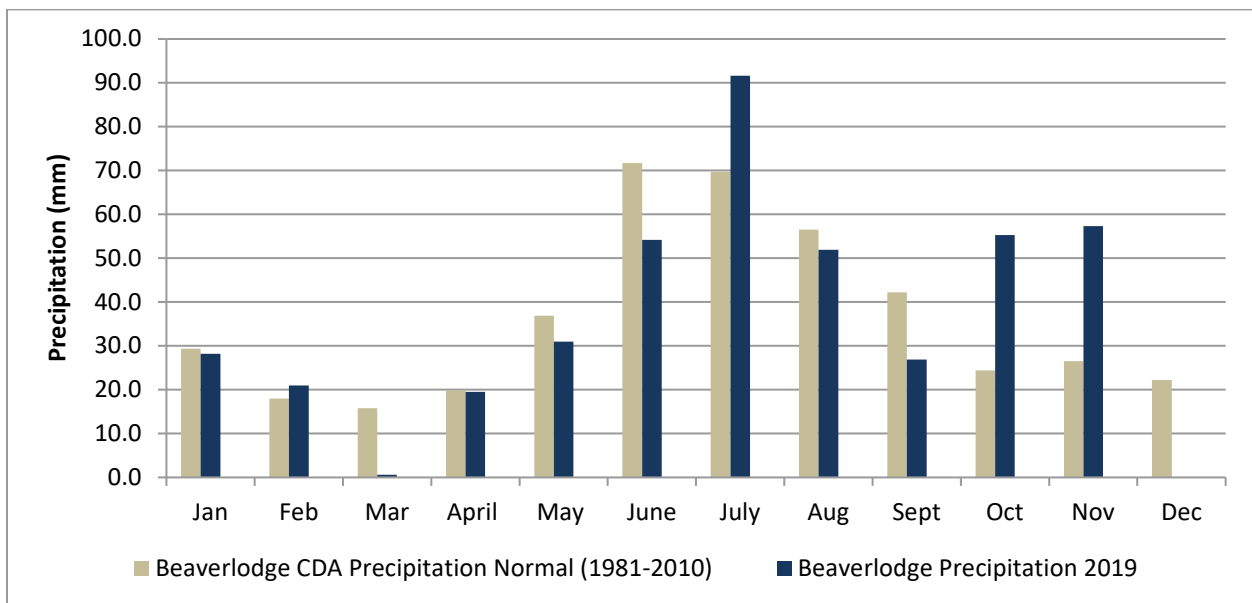
FIGURE 3-1 Beaverlodge Precipitation for 2019 Compared to 30-year Normal Precipitation

Annual precipitation to the end of November was 6% above normal but varied throughout the year. Winter precipitation was near normal in January, February, April and May, while precipitation in March was nearly 100% below normal. Summer precipitation was variable with slightly below normal precipitation in June, August, and September. Greater than normal precipitation was recorded for the months of July, October, and November, contributing to greater low flows in the late-summer and fall.

Precipitation from the Environment Canada Climate Data Archive (CDA) for the Beaverlodge Climate Station (Climate ID: 3070560) for 2019, including a comparison to the 1981-2010 normal precipitation (30-year mean precipitation) is provided in Table 3-1. The monthly variation in precipitation for 2019 from the 1981-2010 normal precipitation are shown as percent differences indicating the dominant wet or dry runoff conditions over the course of the year (Table 3-1; Figure 3-1).

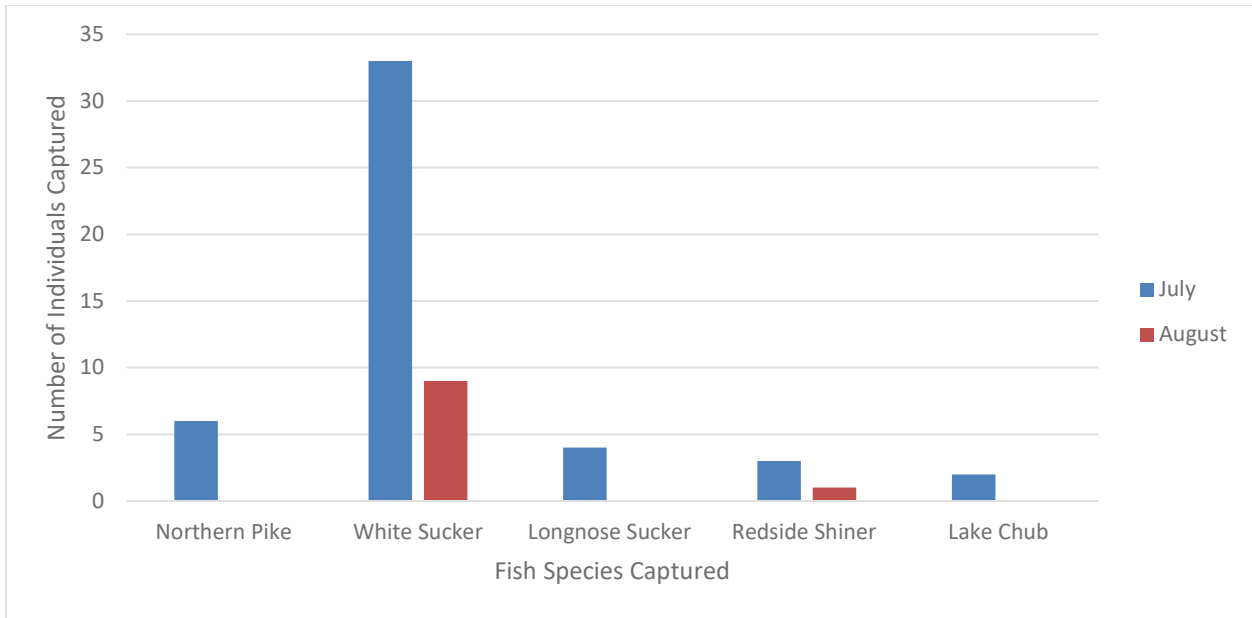
FIGURE 3-2 Species Abundance- Total

White Sucker was the most abundant species during both sampling events, with 33 individuals captured in July, and 9 individuals captured in August (Figure 3-2). Northern Pike was the only sport fish species captured; 6 individuals were captured during the July fish sampling efforts; no pike were captured during August fishing efforts (Figure 3-2).

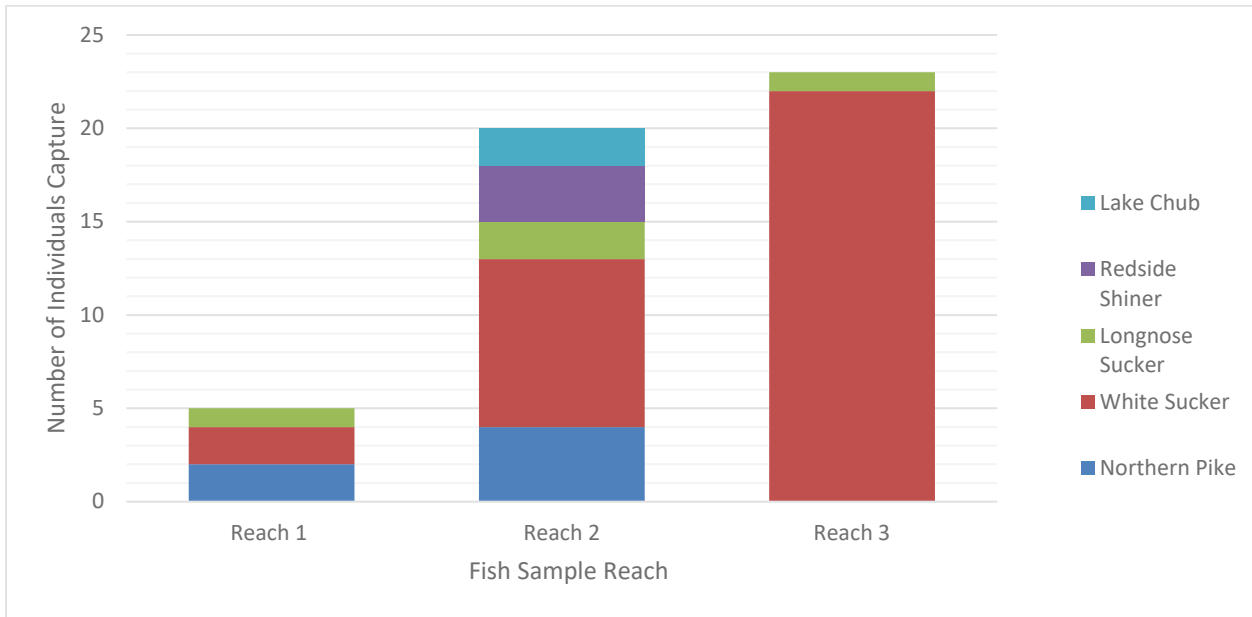
FIGURE 3-3 July Species Abundance- By Sampling Reach

Species distribution between the three sampling areas (Figure 3-3) was noted; Northern Pike were captured in both Reach 1 and Reach 2 (Figure 3-3). Longnose Sucker and White Sucker were captured in each sampling reach, Redside Shiner was captured in Reaches 1 and 2, and Lake Chub were only captured in Reach 2 (Figures 3-3 and 3-4).

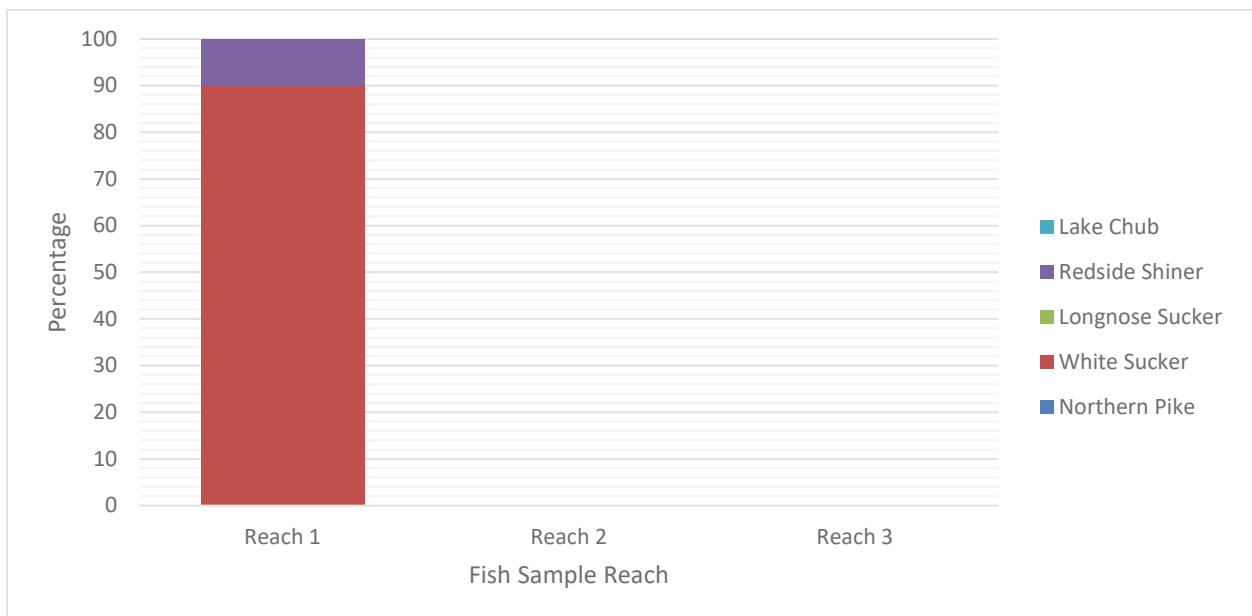
FIGURE 3-7 August Species Composition- by Sampling Reach (Reach 2 and 3 Were Not Sampled)

Reach 1 was the only location sampled within the study area during the month of August. Fishing efforts resulted in 90% White Sucker of the species composition, with Reside Shiner representing the remaining 10% of the species composition within reach 1 (Figure 3-7).

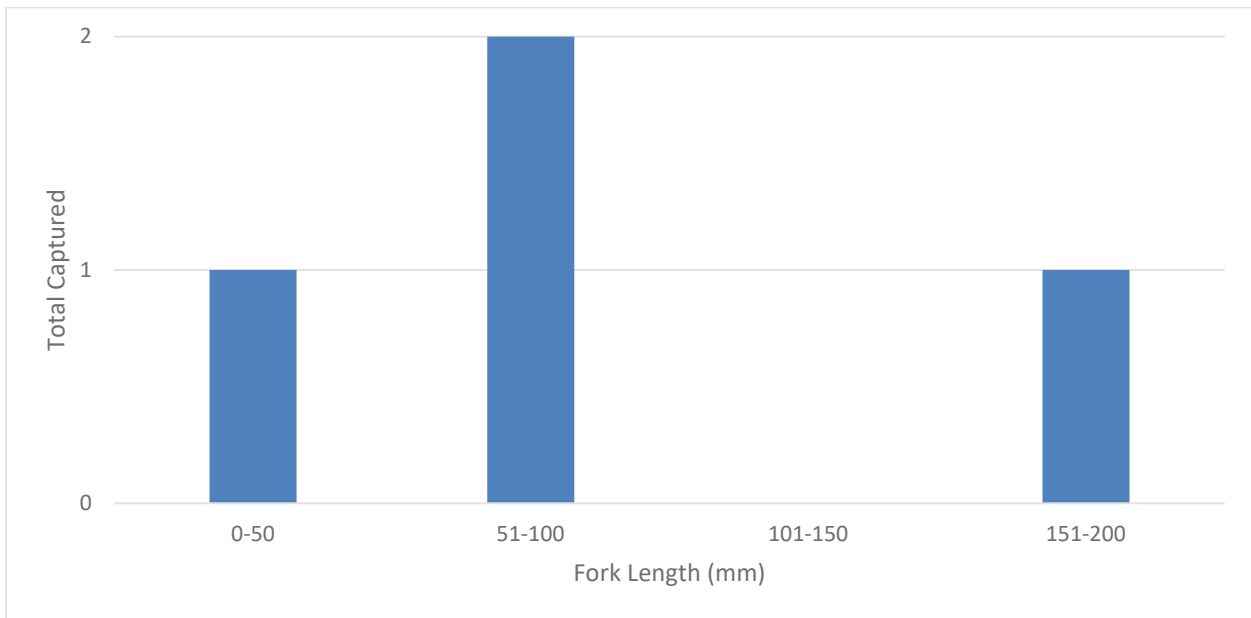
FIGURE 3-8 Longnose Sucker Fork Length Distribution

Longnose sucker fork length distribution included 0-50, 51-100 and 151-200 mm (Figure 3-8). In the case of White Sucker, the majority of individuals captured displayed fork length ranges of 151-300 mm (Figure 3-9).

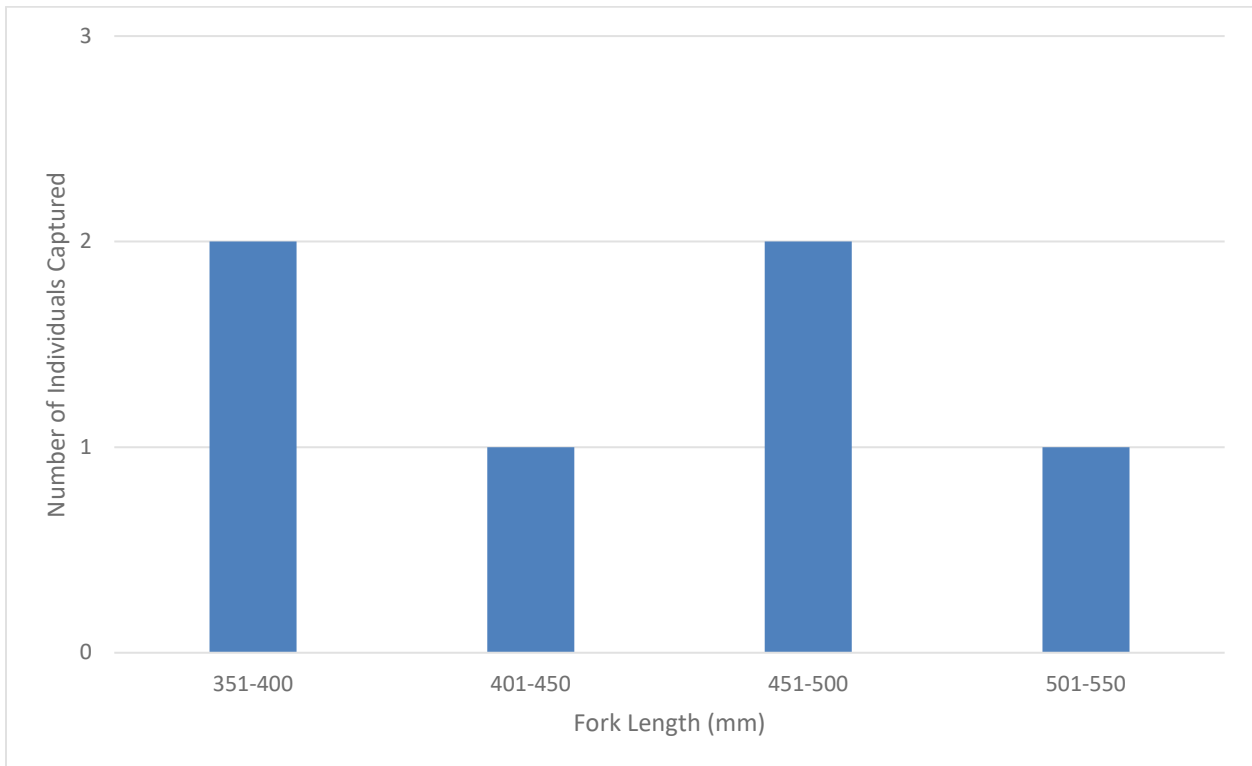
FIGURE 3-10 Northern Pike Fork Length Distribution

Fork length for Northern Pike were among the last four fork length ranges, which included 351 to 400 mm, 401 to 450 mm, 451 to 500 mm, 501 to 550 mm (Figure 3-11).
